**DEPARTMENT OF TRANSPORTATION**

Contract #: 04-0120F4Cty: SF/ALA Rte: 80 PM: 13.2/13.9File #: 69.28**WELDING INSPECTION REPORT****Resident Engineer:**Pursell, Gary**Address:** 333 Burma Road**City:** Oakland, CA 94607**Report No:** WIR-002664**Date Inspected:** 11-May-2008**Project Name:** SAS Superstructure**OSM Arrival Time:** 700**Prime Contractor:** American Bridge/Fluor Enterprises, a JV**OSM Departure Time:** 1700**Contractor:** Zhenhua Port Machinery Company, Ltd (ZPMC), Changxing Island **Location:** Shanghai, China**CWI Name:** Sun Wei**CWI Present:** Yes No**Inspected CWI report:** Yes No N/A**Rod Oven in Use:** Yes No N/A**Electrode to specification:** Yes No N/A**Weld Procedures Followed:** Yes No N/A**Qualified Welders:** Yes No N/A**Verified Joint Fit-up:** Yes No N/A**Approved Drawings:** Yes No N/A**Approved WPS:** Yes No N/A**Delayed / Cancelled:** Yes No N/A**Bridge No:** 34-0006**Component:** OBG**Summary of Items Observed:**

**New Tower Facility Bay 3**

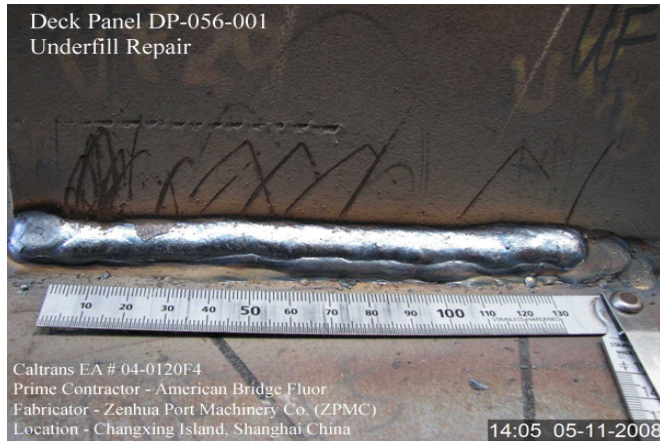
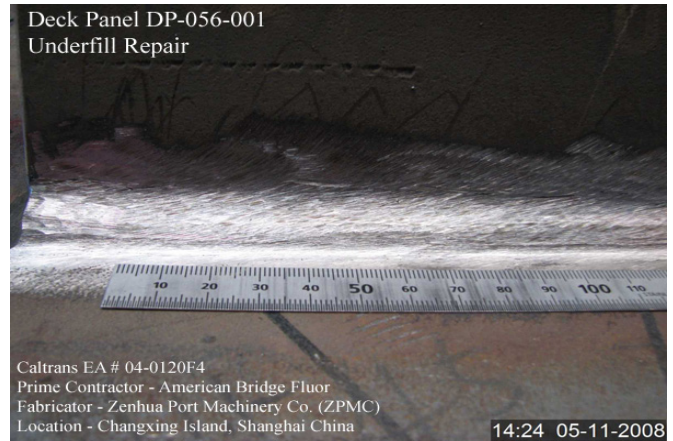
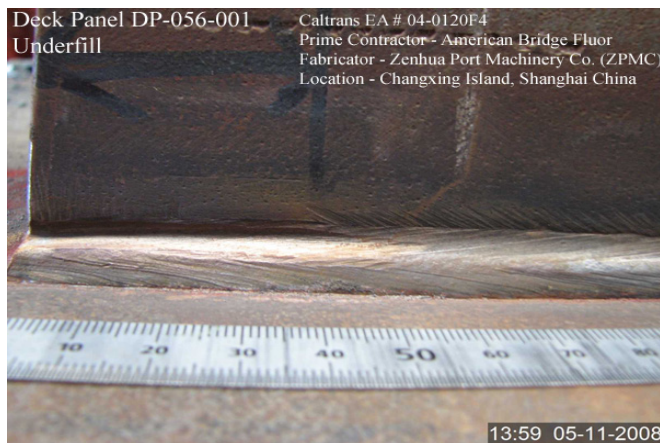
The Quality Assurance Inspector observed ZPMC performing weld repairs to Deck Panel DP-056-001. ZPMC was observed repairing weld defects such as undercut, incomplete fusion, and underfill. The repair welding was performed in accordance with WPS-345-FCAW-2G(2F)-repair. The Quality Assurance Inspector updated onsite logs tracking the repairs. Below are three digital photographs illustrating the three stages of repair.
